# Offshore Marine Repair Works at Berth 53

Jubail Industrial Port

Client : Sea Ports Authority  
Consultant : Al Hamdan Consulting Office

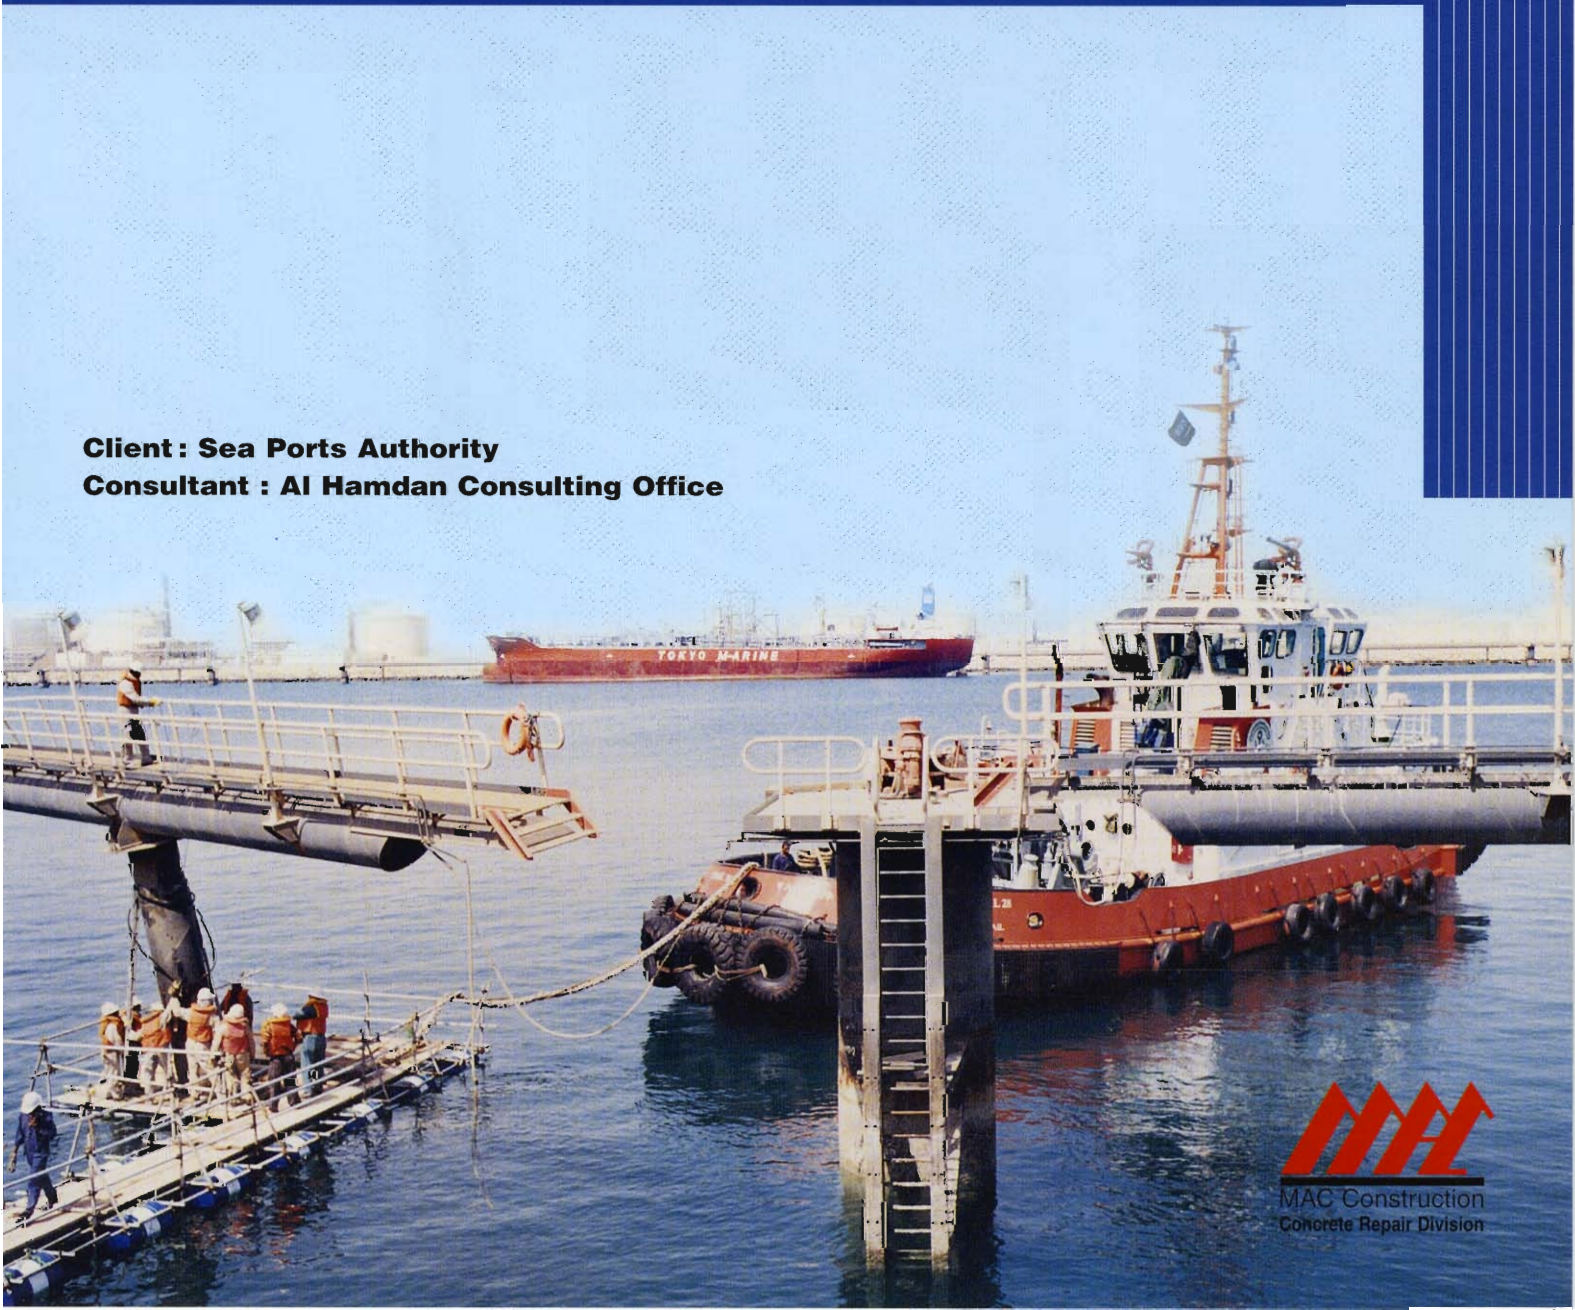
A suspended walkway, extending approximately 100m from the pavement of Berth No. 53 into the sea, was accidentally hit by a ship causing its supporting steel pile to move out of alignment and shifting the walkway out of its original position.

MAC was awarded a contract by the Sea Port Authority in Jubail to perform the corrective work of realigning the pile to its original vertical position and encasing its sea bed bottom section with concrete, 14m below sea level, and to a depth of 1m.

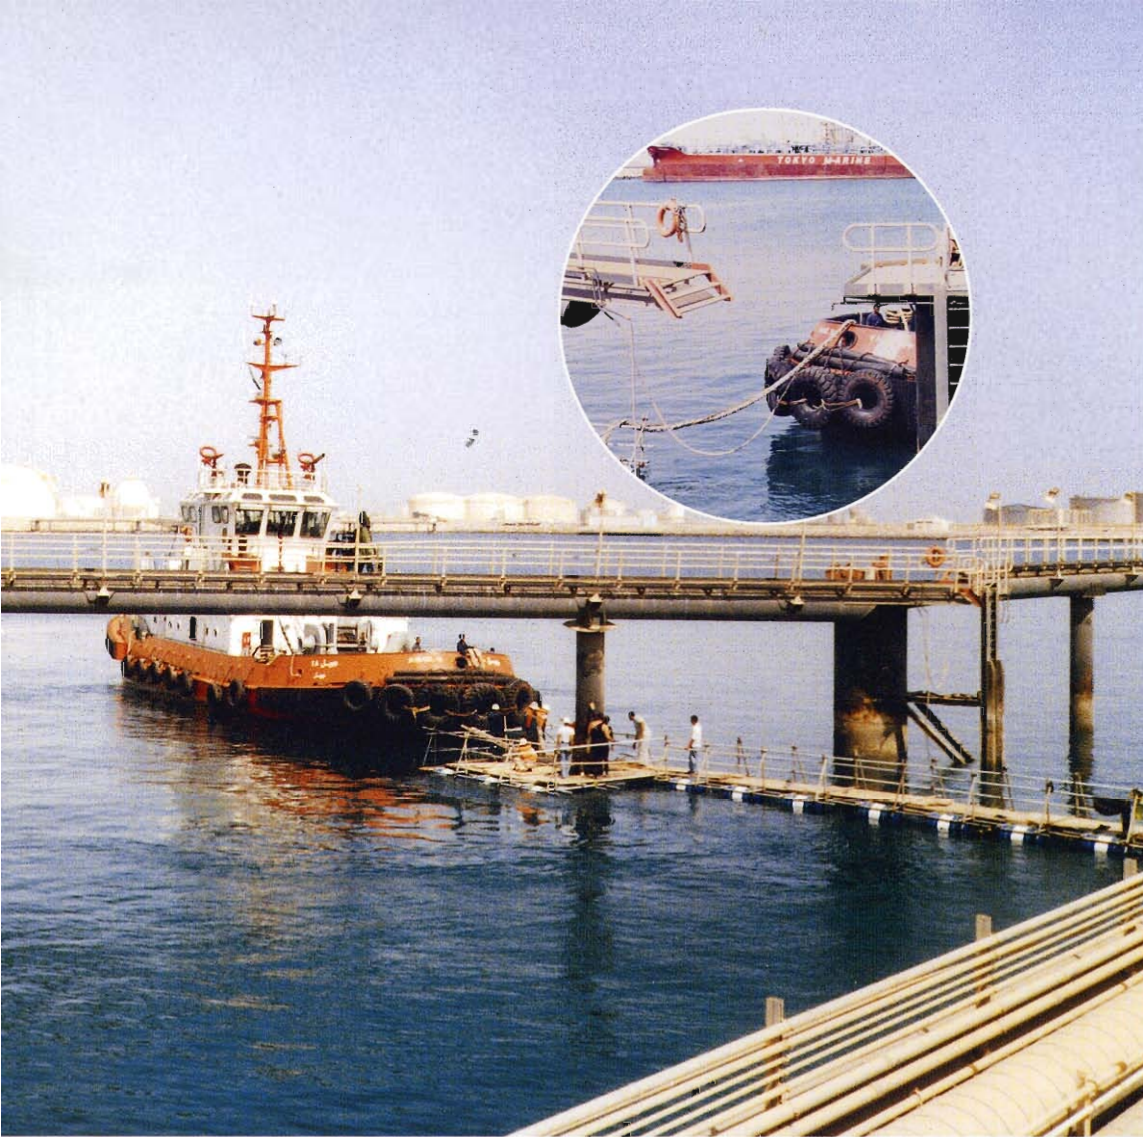
A specially formulated underwater concrete mix was used to fill the cofferdam/formwork. The picture shows the static pump used to pour the tremmie concrete.

- /// Pouring underwater concrete into the cofferdam/formwork to fill it completely and let it overflow on all sides thus leaving the cofferdam fully encased. A static pump was used to pour the tremmie concrete
